# Cypress Creek Flow Study: Blanco and Travis Counties, Texas

Report: 2021-01  
January 2021

# Cypress Creek Flow Study Blanco and Travis Counties, Texas

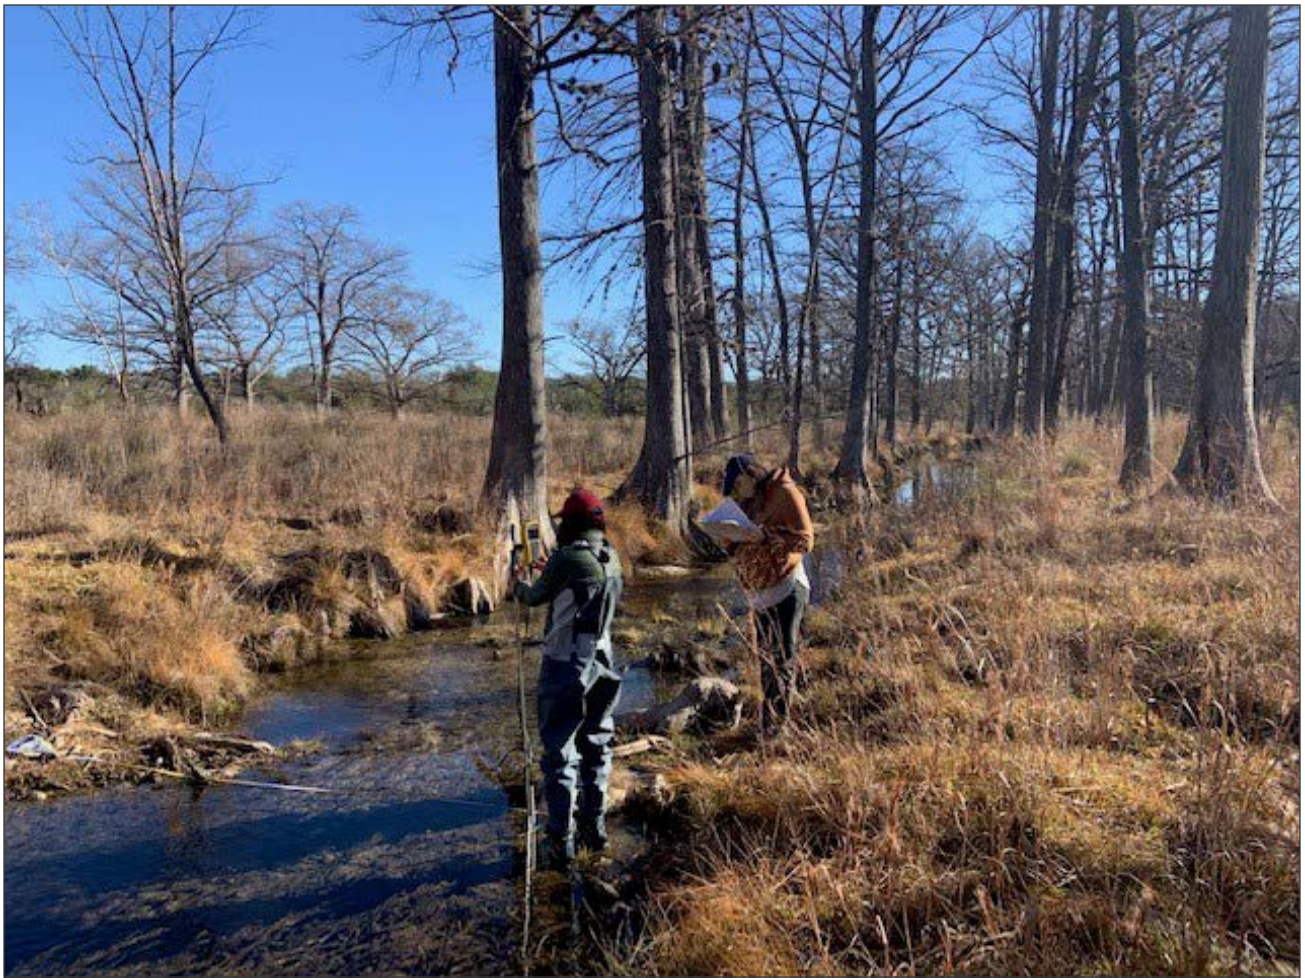
**Figure 5.** Meadows Center staff measuring flow with the Sontek FlowTracker sonde

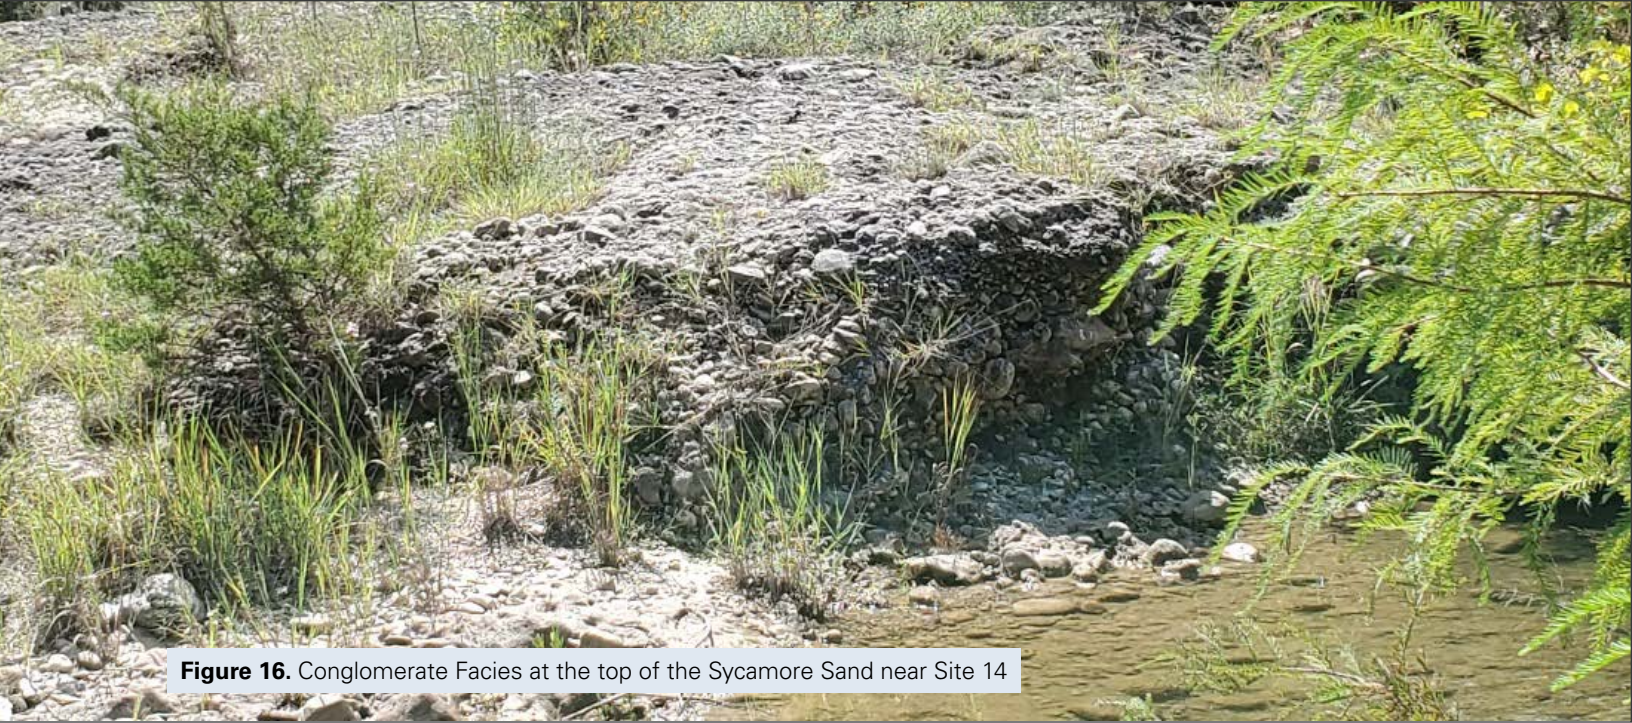
**Figure 16.** Conglomerate Facies at the top of the Sycamore Sand near Site 14

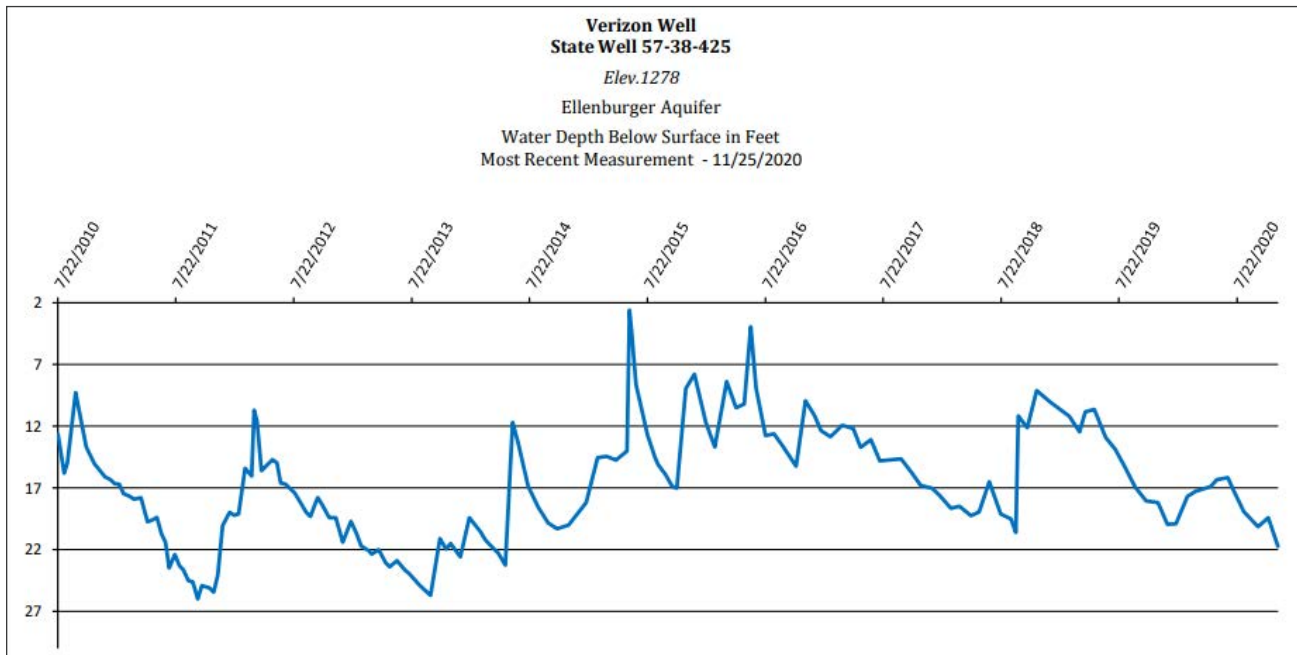
**Figure 17.** Verizon Well Water Level Monitoring Results (Source: BPGCD, 2020)
