BLANCO RIVER VALLEY RIPARIAN RESTORATION PROJECTS:
LOCAL VALUES AND DECISIONS FOR RIPARIAN HABITAT
MANAGEMENT FOLLOWING THE 2015 MEMORIAL DAY FLOODS
IN WIMBERLEY, TEXAS

HONORS THESIS

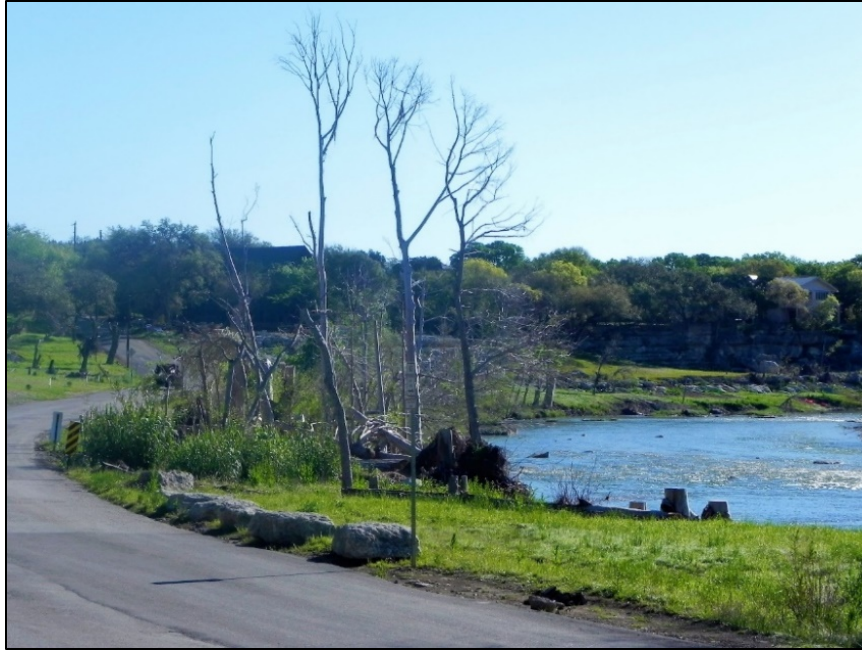
Figure 1. TPWD Conservation Demonstration Program Site1
Riparian zone fragmentation along the Blanco River is common.
This is one of the most privatized rivers in central Texas.
