RIPARIAN AND GEOMORPHIC DISTURBANCE FROM A
HIGH-MAGNITUDE FLOOD ON THE BLANCO RIVER
IN THE TEXAS HILL COUNTRY

A thesis submitted to the Graduate Council of
Texas State University in partial fulfillment
of the requirements for the degree of
Master of Science
with a Major in Geography
May 2017

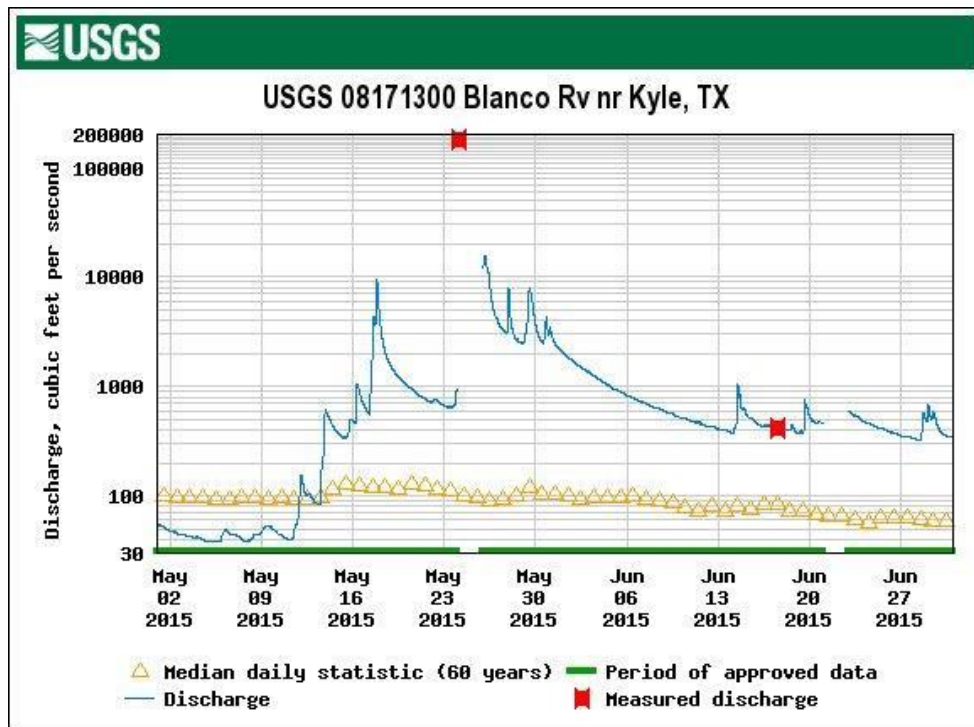
Figure 1 Discharge at the USGS Blanco River near Kyle gage for May 2, 2015 to June 27, 2015 in cubic feet per second

discharge estimates for the flood at the Blanco River near Kyle USGS gage range from 175,000-180,000 ft^3s^{-1} (USGS 08171300, NWIS 2016).

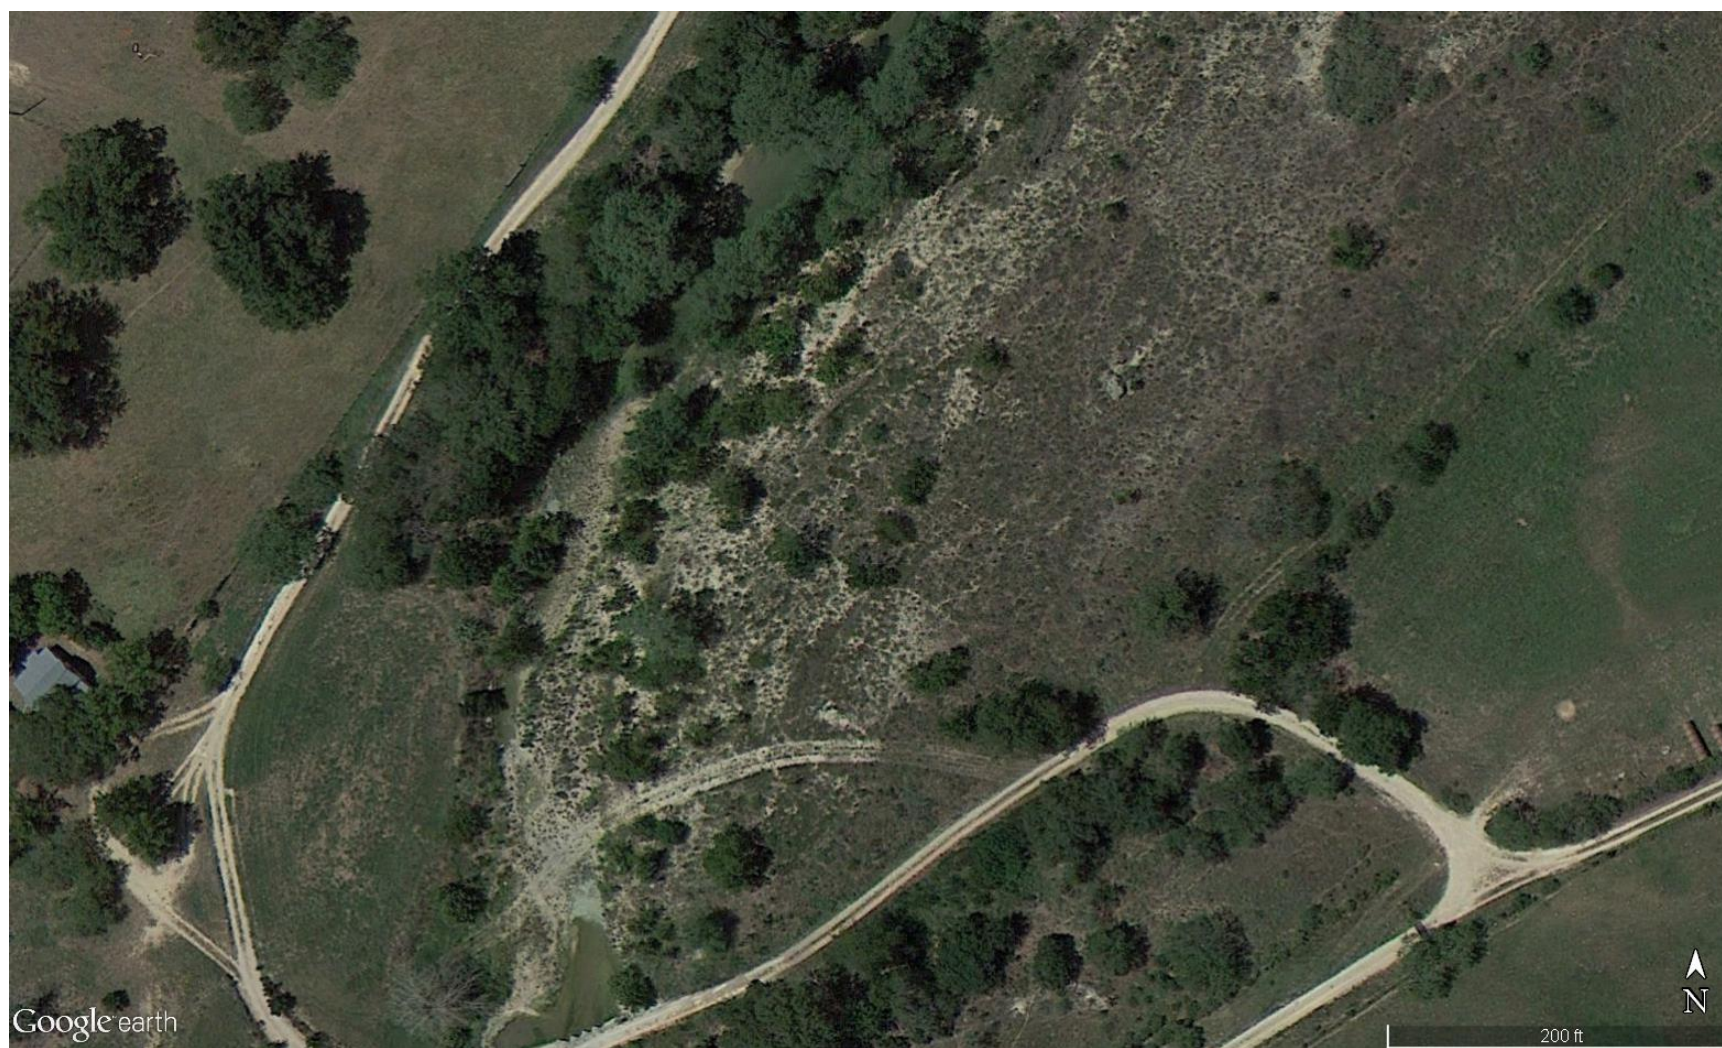
Figure 19 The Blanco River Pre-October Flood. A section of the Blanco River before the October 2013 flood event.

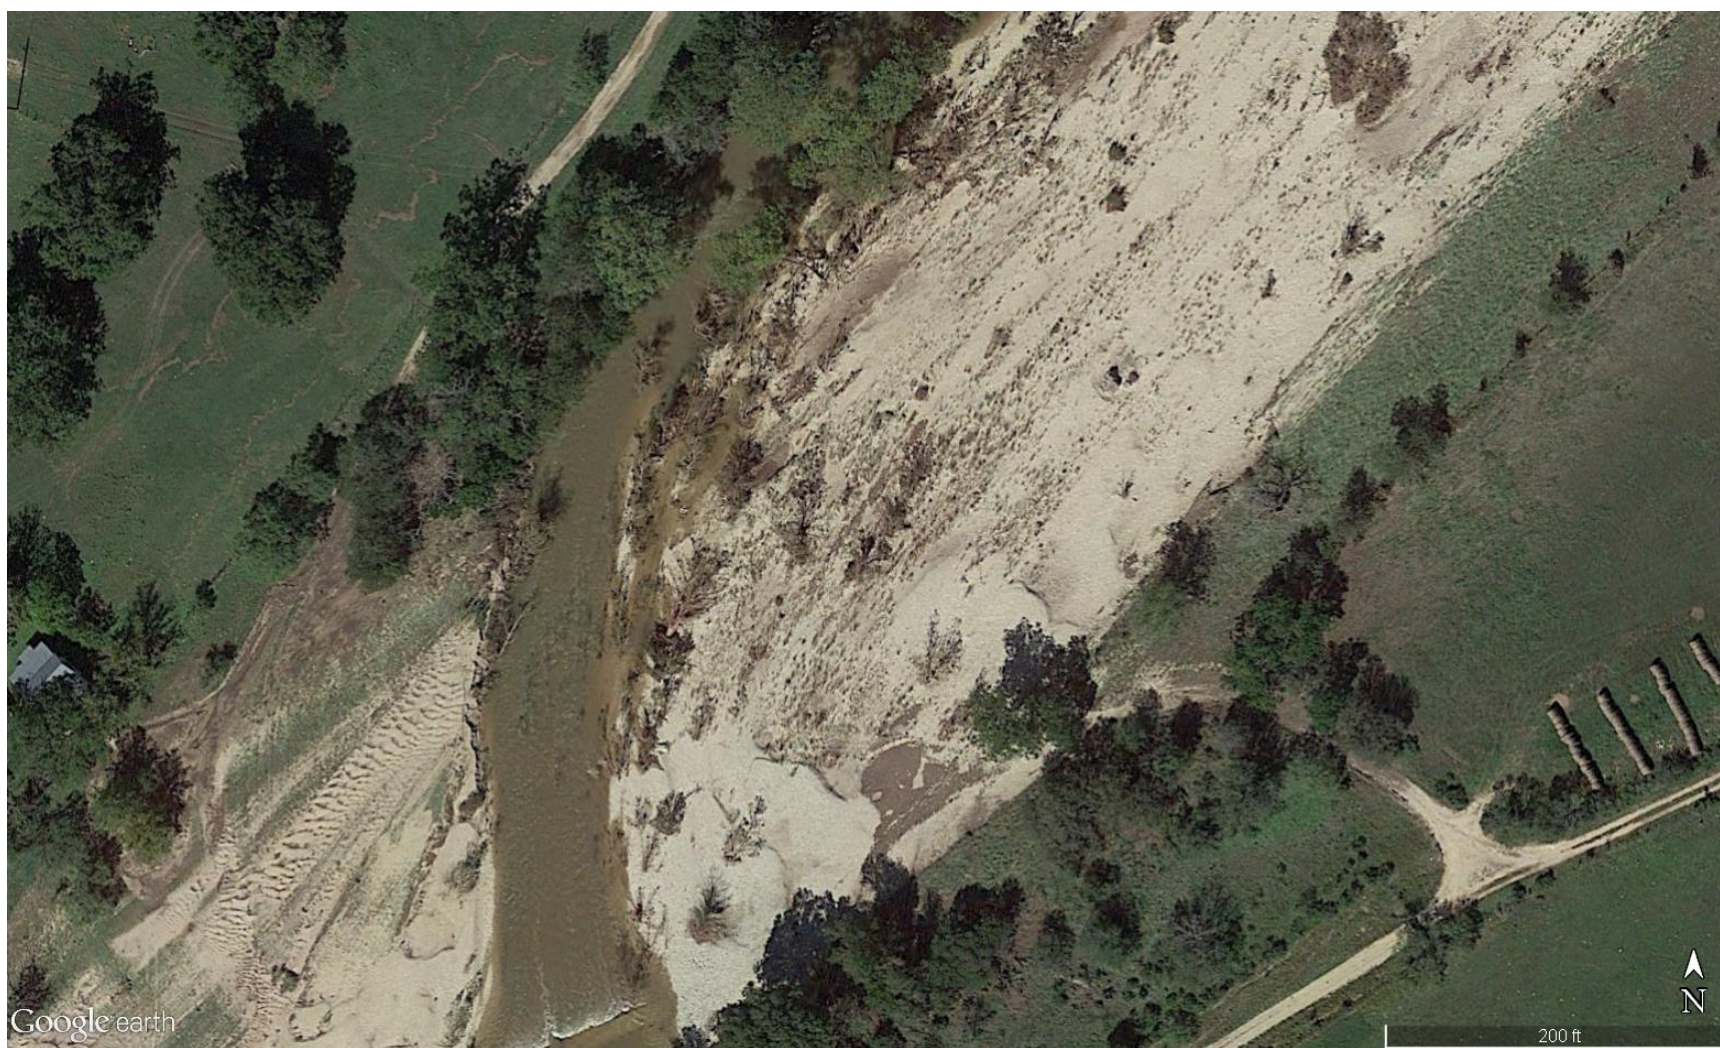
Figure 20 The Blanco River Post-October Flood. A section of the Blanco River after the October 2013 flood event.

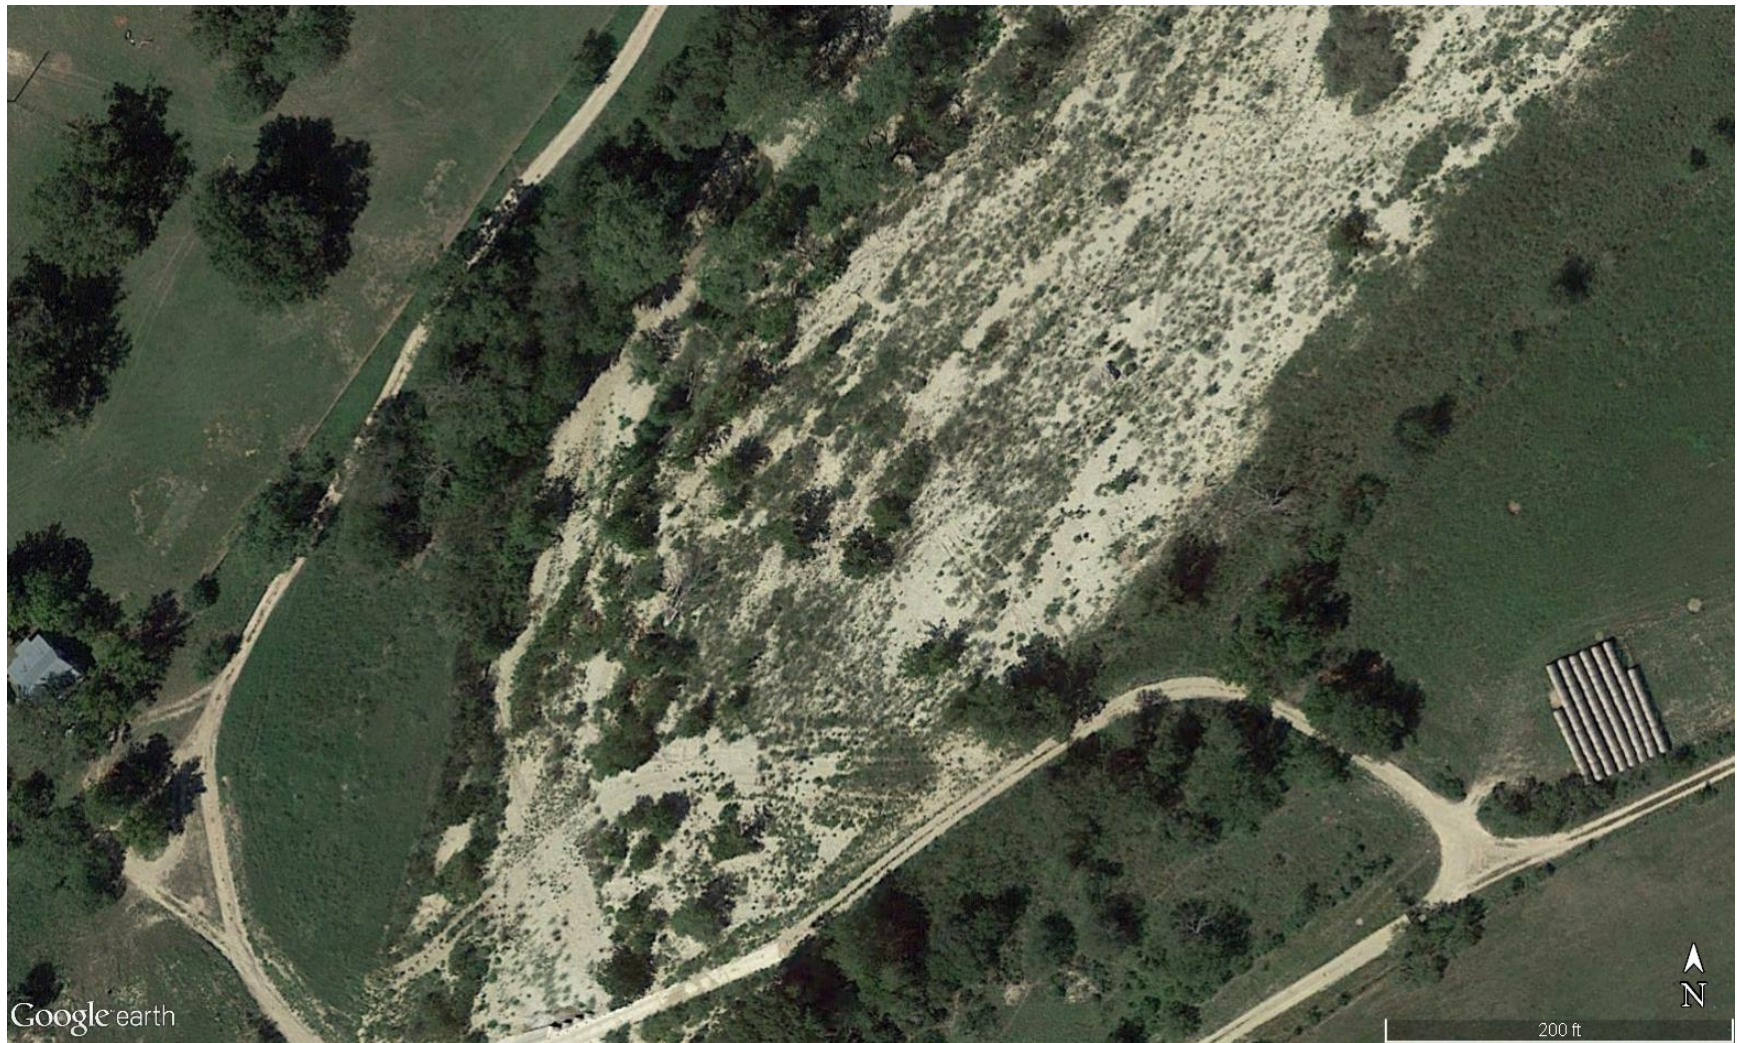
Figure 21 The Blanco River Pre-Memorial Day Flood. A section of the Blanco River which has recovered from the 2013 flood event. Captured before the 2015 Memorial Day flood event.

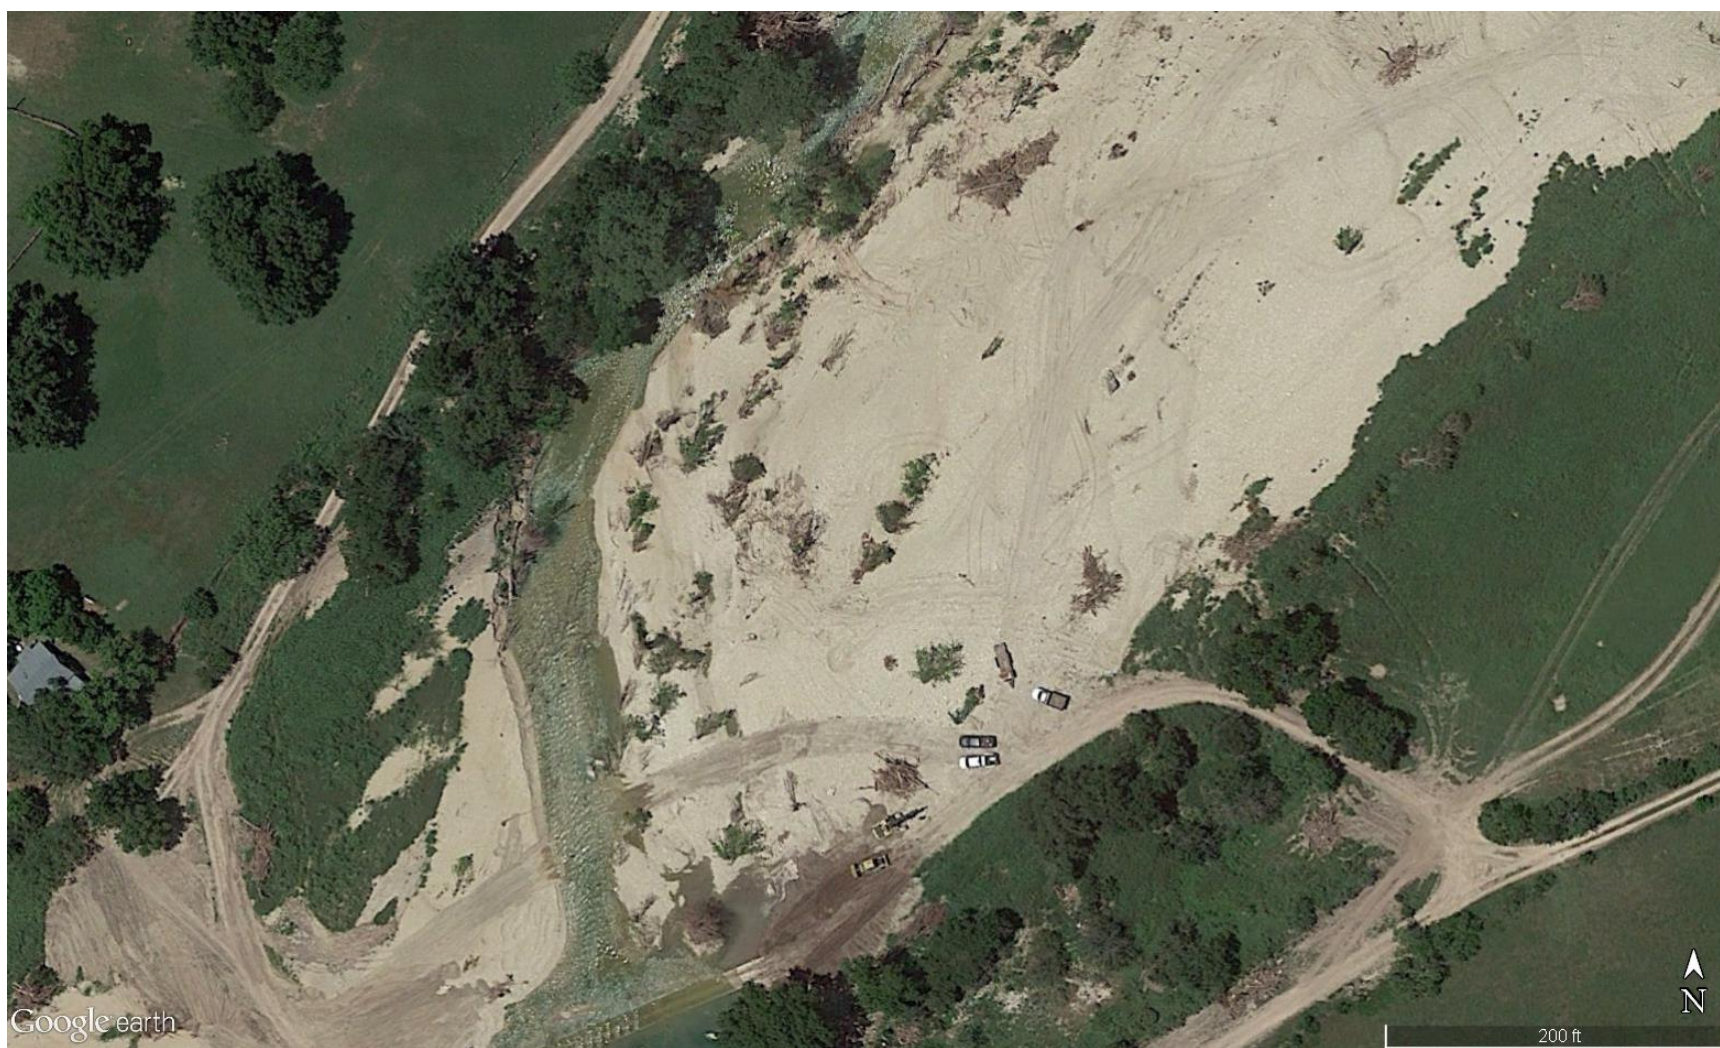
Figure 22 The Blanco River Post-Memorial Day Flood. A section of the Blanco River after the 2015 Memorial Day flood event. Similar disturbance patterns are seen with the 2015 flood as were seen with the 2013 flood.
