THE INFLUENCE OF LAND USE/LAND COVER WITHIN RIPARIAN
ENVIRONMENTS ON CHANNEL CHANGE ON THE GUADALUPE RIVER,
TEXAS

THESIS

Master of APPLIED GEOGRAPHY

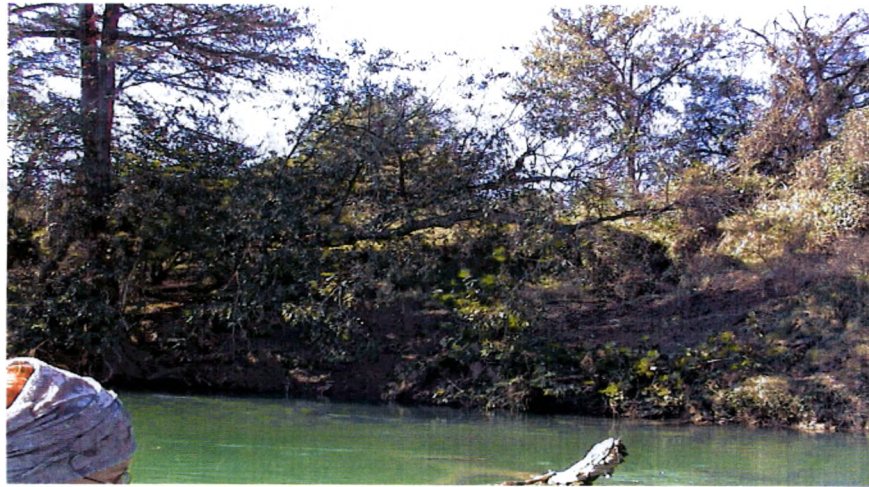
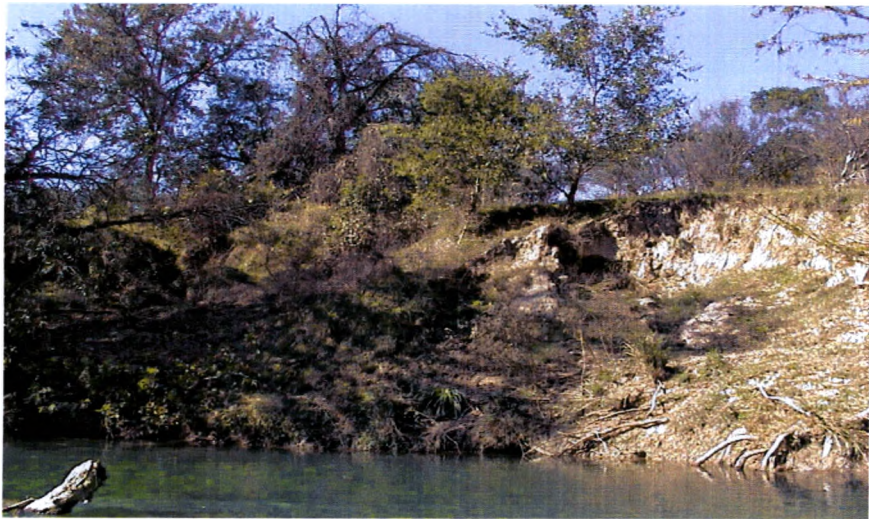
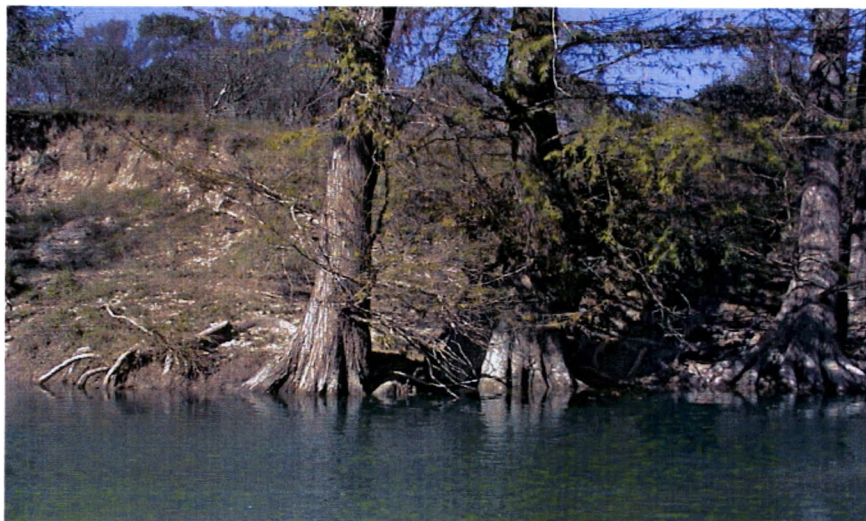
Figure 33 Channel Widening Site 2

Channel Widening Site 2 (Figures 32 and 33)

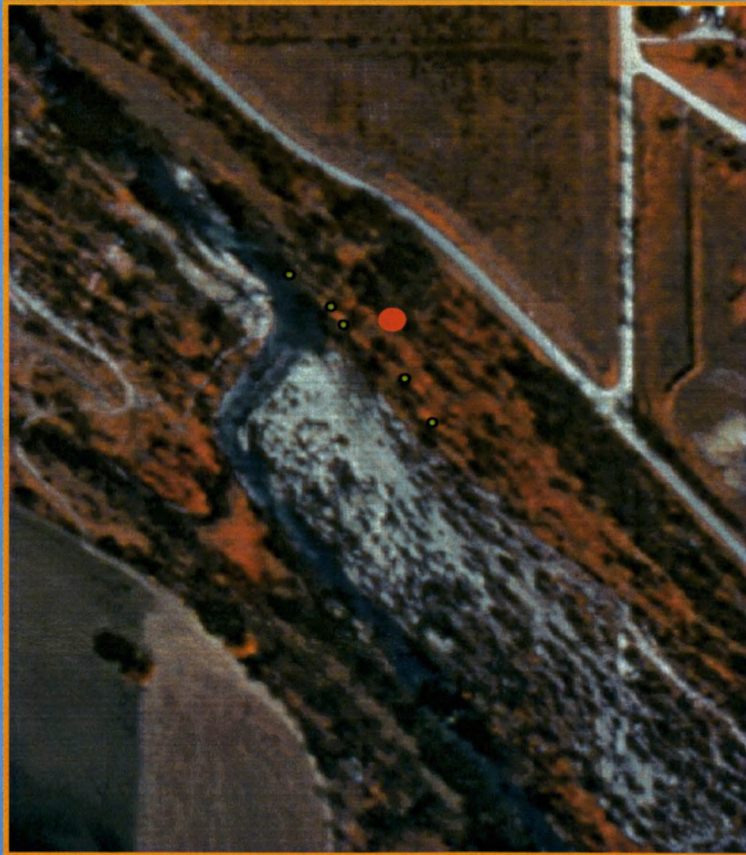
Figure 36

This site is a good illustration of the process that is outlined above. It is clear that as the river exceeds bankfull stage a new channel is formed to carry and dissipate the increased flow energy. In this example the river has straightened its course. Under normal conditions the river would flow through a series of bends, but as the increased water volume fills the channel, the flow travels straight across and over the river bends.

This site has emerged as significant due to the large distance of the observed erosion feature from the channel during normal flow conditions. On the 1955 images there is scattered vegetation in the area that has been eroded by flood flows by 1996. On the 1996 image the scouring action of the increased flood flow on the river bank is evident.

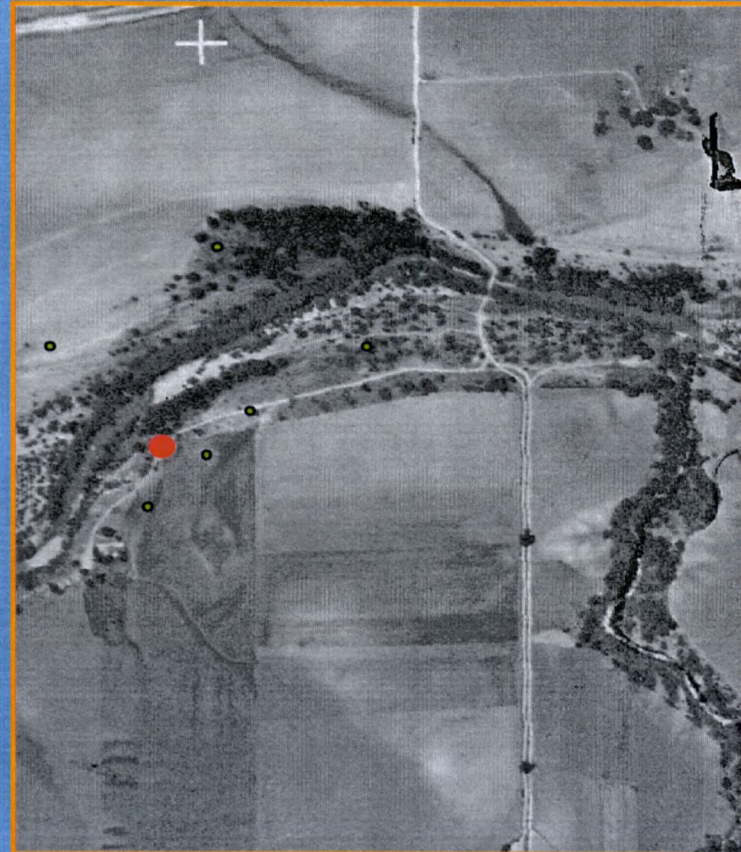
- Current Erosion
- Location of Flood Channel 2

At this site the increased flow of a flood event has gone past bank full height and established a new floodplain. Large lines of erosion are visible on either side of the channel. On the 1955 aerial photographs agricultural activities in close proximity to the channel are observed and only a small riparian area is visible. The 1996 images illustrate how the riparian vegetation has been thinned further. Large amounts of land have been lost as the area has become dominated by depositional bars both above and below the erosion sites.

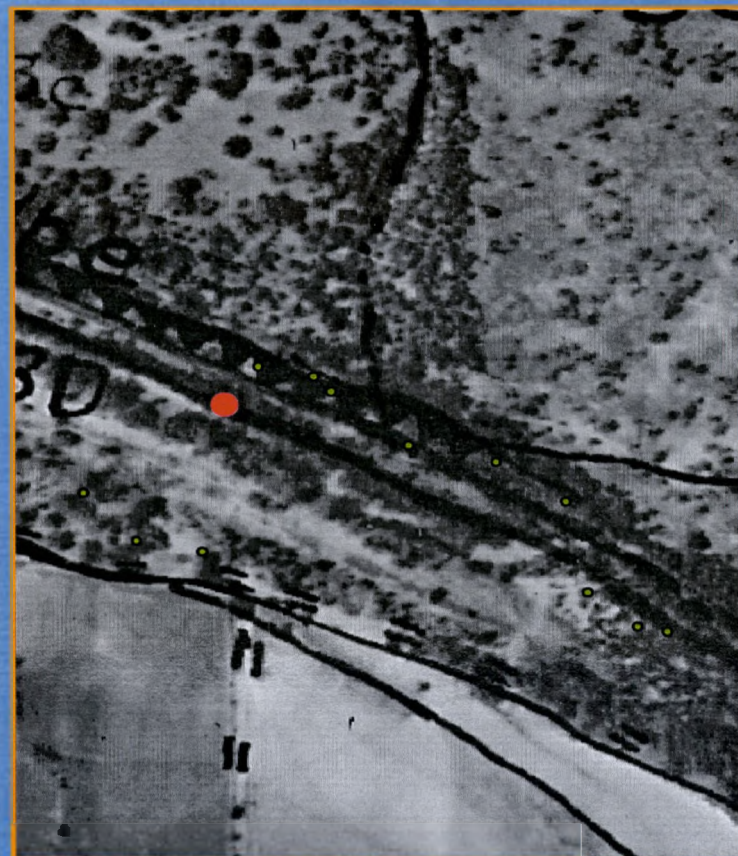
Figure 40

This site is another example of the results of flows beyond bankfull flow. There is evidence of riparian vegetation thinning but unfortunately the 1955 aerial photograph has been marked on, making interpretation of the site difficult.

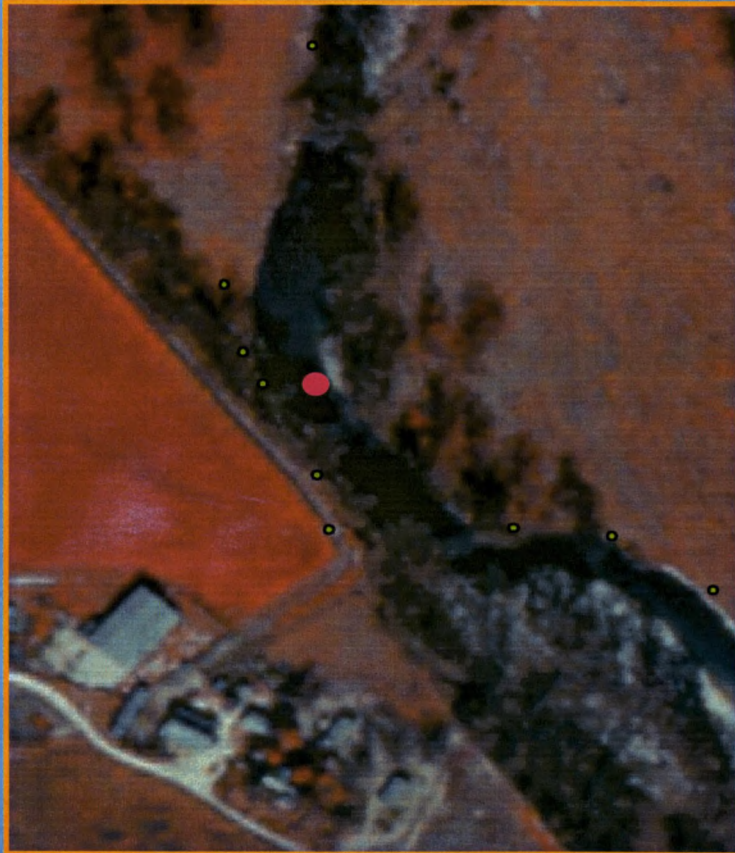
Channel Meander Site 1

At its smallest in 1955, the riparian vegetation band was 26 meters wide. It was further reduced to 11 meters in 1996. Deposition of a sediment bar on the inside of the channel indicates on-going meandering processes. An associated increase in velocity on the outside of the bend combines with reduction in riparian vegetation to cause visible amounts of channel change. The reduction in vegetation in combination with the increased velocity on the outside of the bend have resulted in the channel change that is

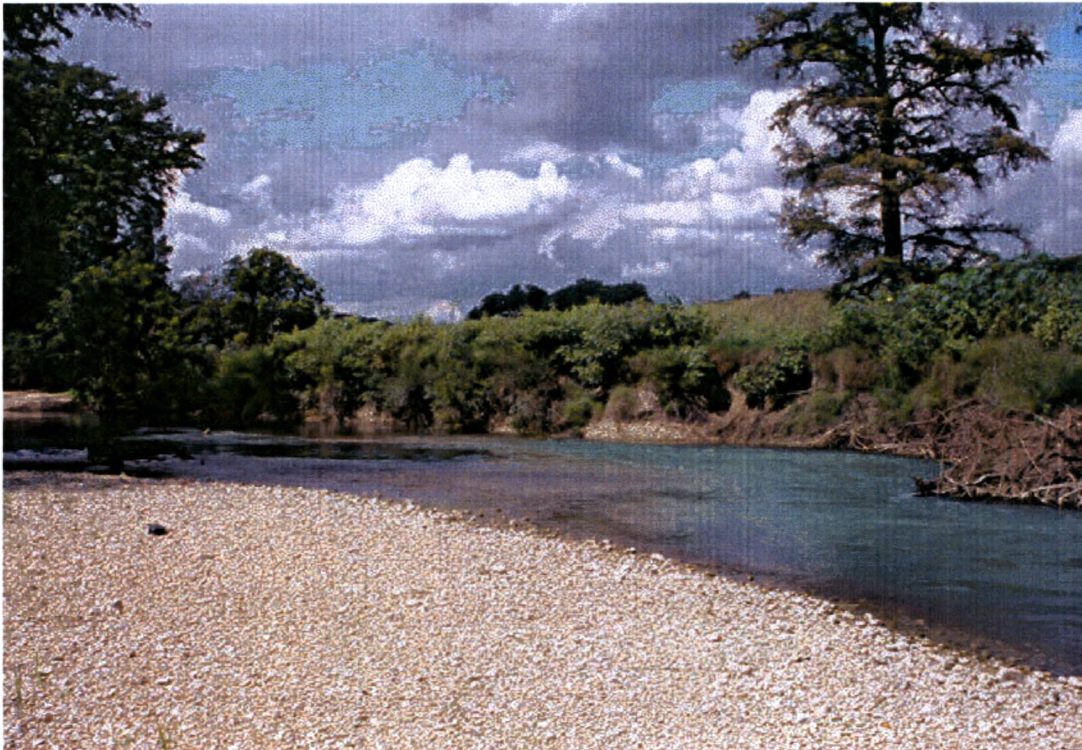
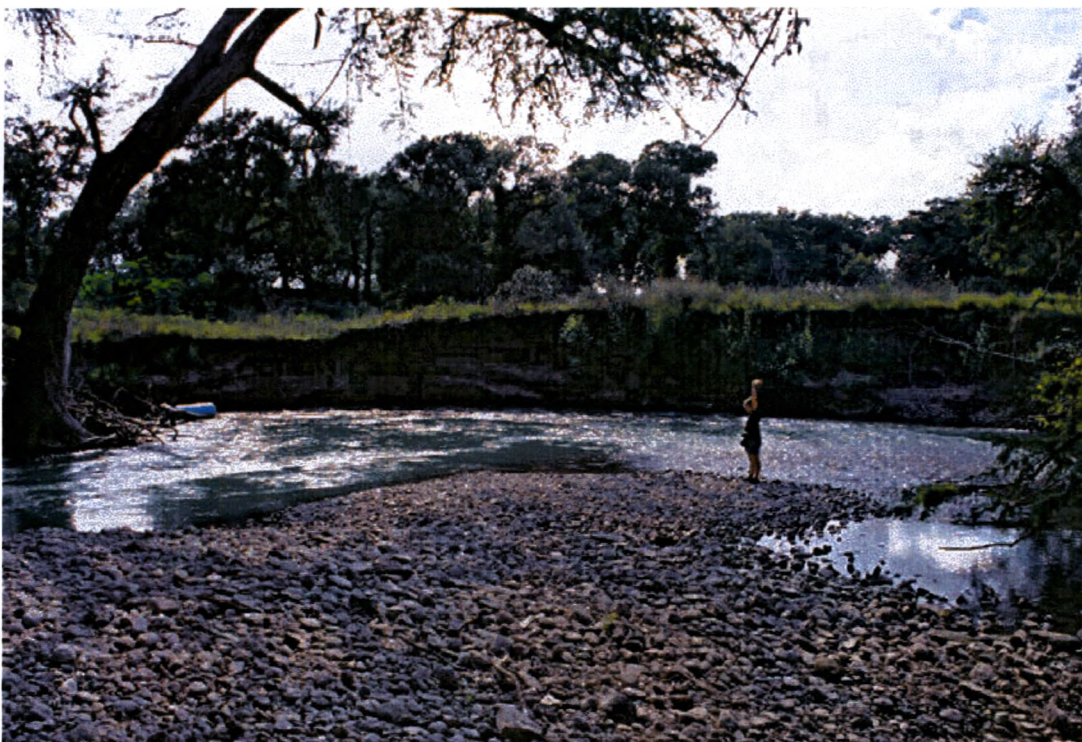
Figure 43 Channel Meander I

evident. More generally one can see a development in the area near the affected portion of river.

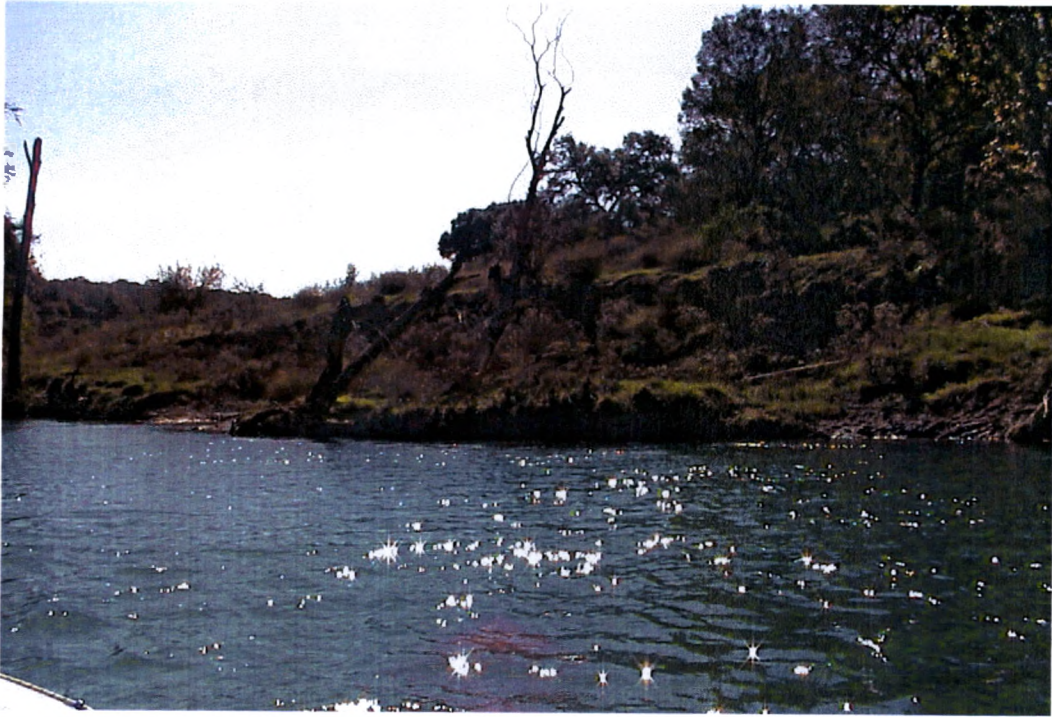
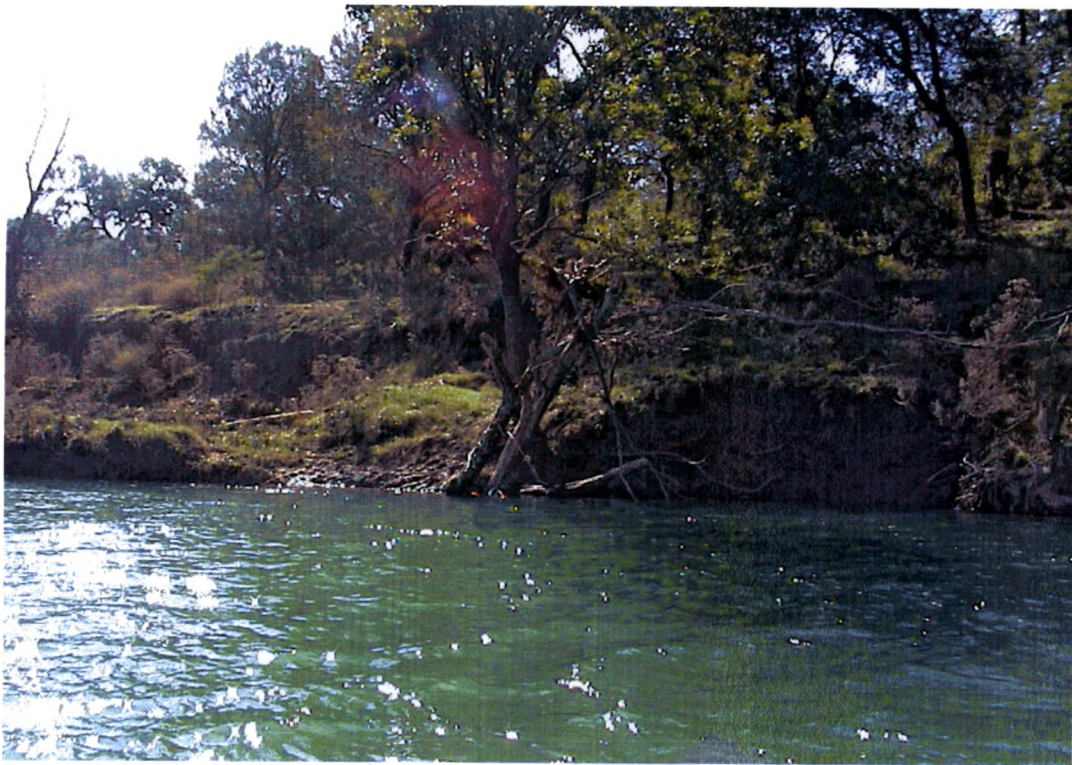
Figure 45 Channel Meander 2

Channel Meander Site 2 (Figures 44 and 45)

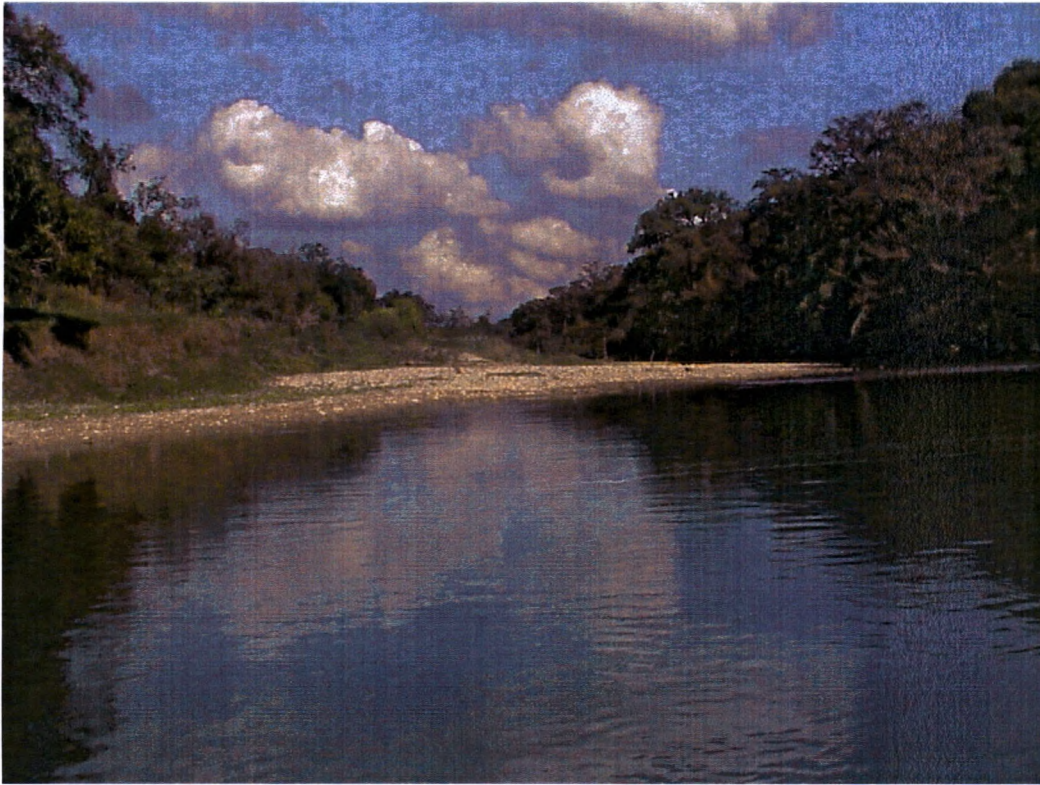
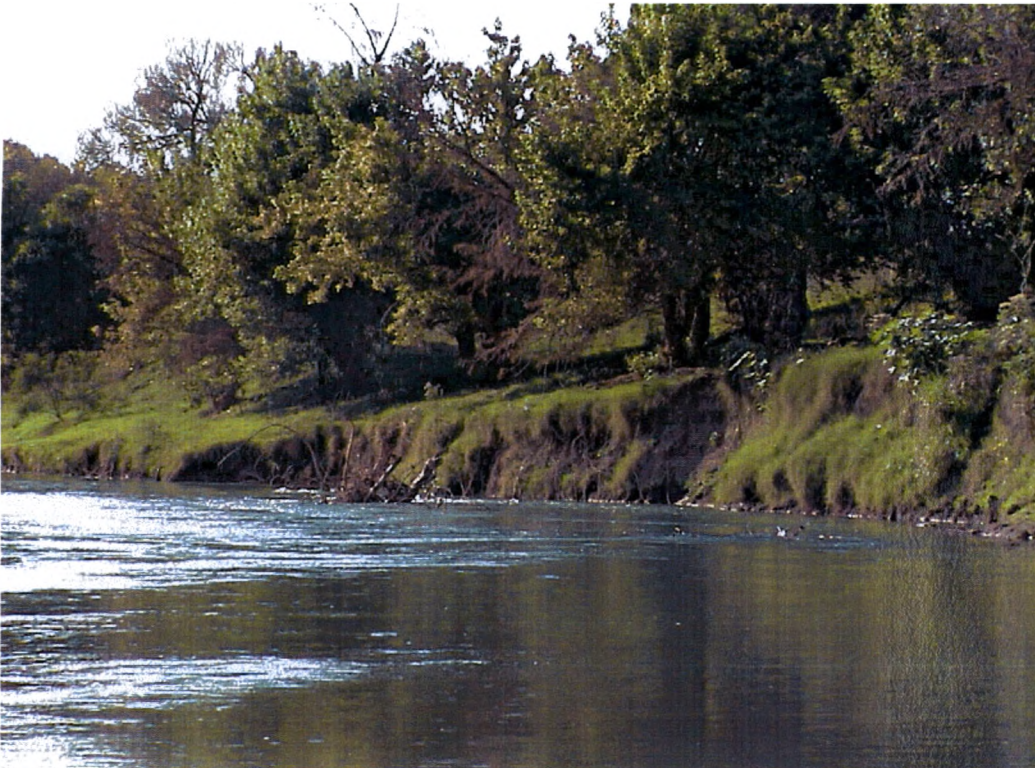
Figure 47 Channel Meander 3

Channel Meander Site 3 (Figures 46 and 47)
